Situation Photo Log

Wednesday, August 29, 2012

Kalamazoo River / Enbridge Spill

Prepared by:
Larry Rader
START-USEPA
Situation Unit Leader

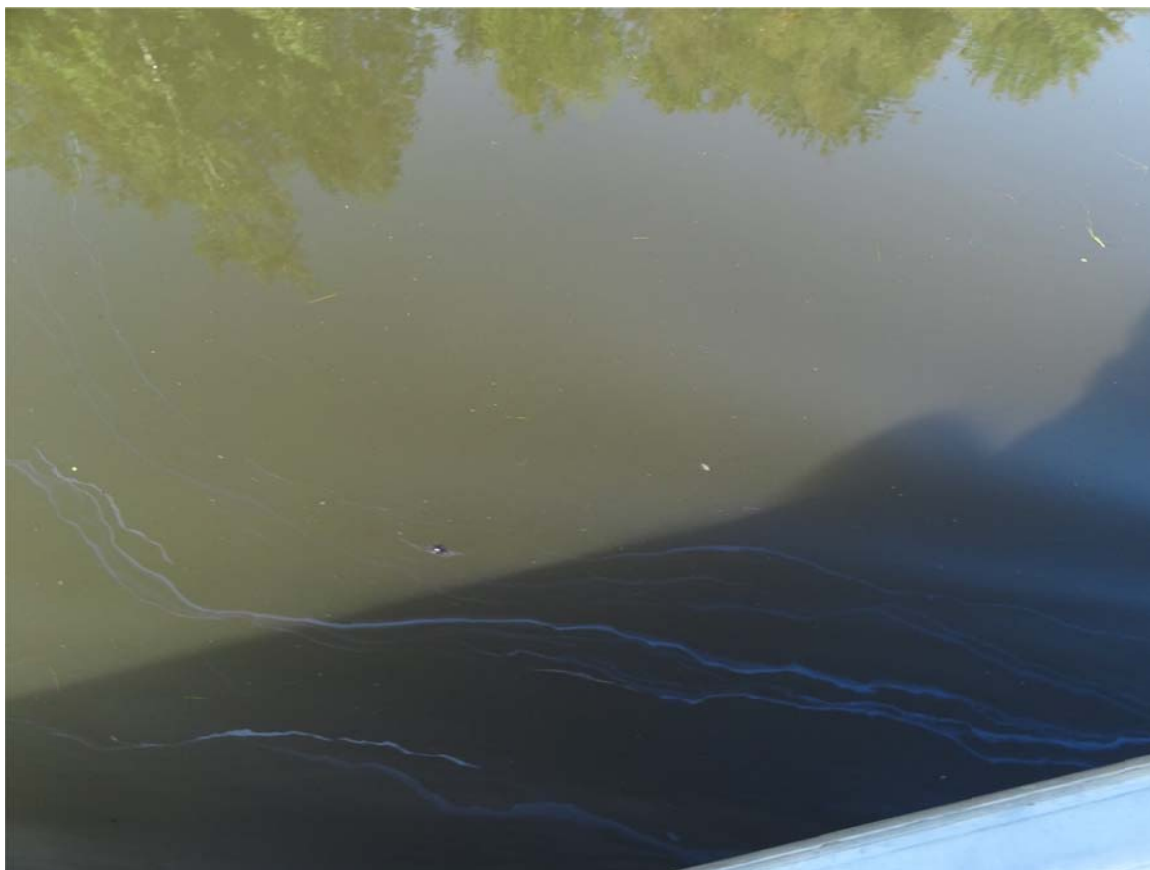
1. Sheen and tar globules observed at the trestle above Ceresco Dam.

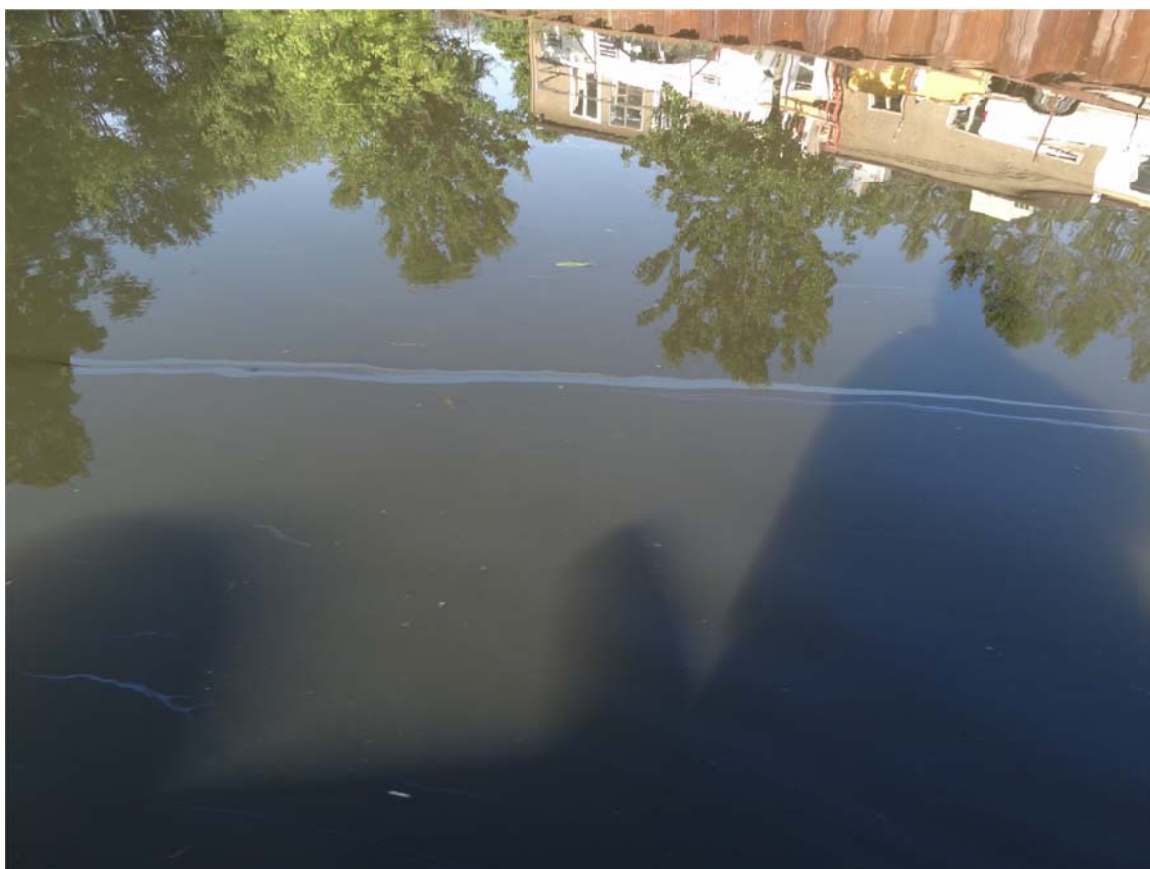
2. Sheen and tar globules observed within containment at Ceresco Dam.

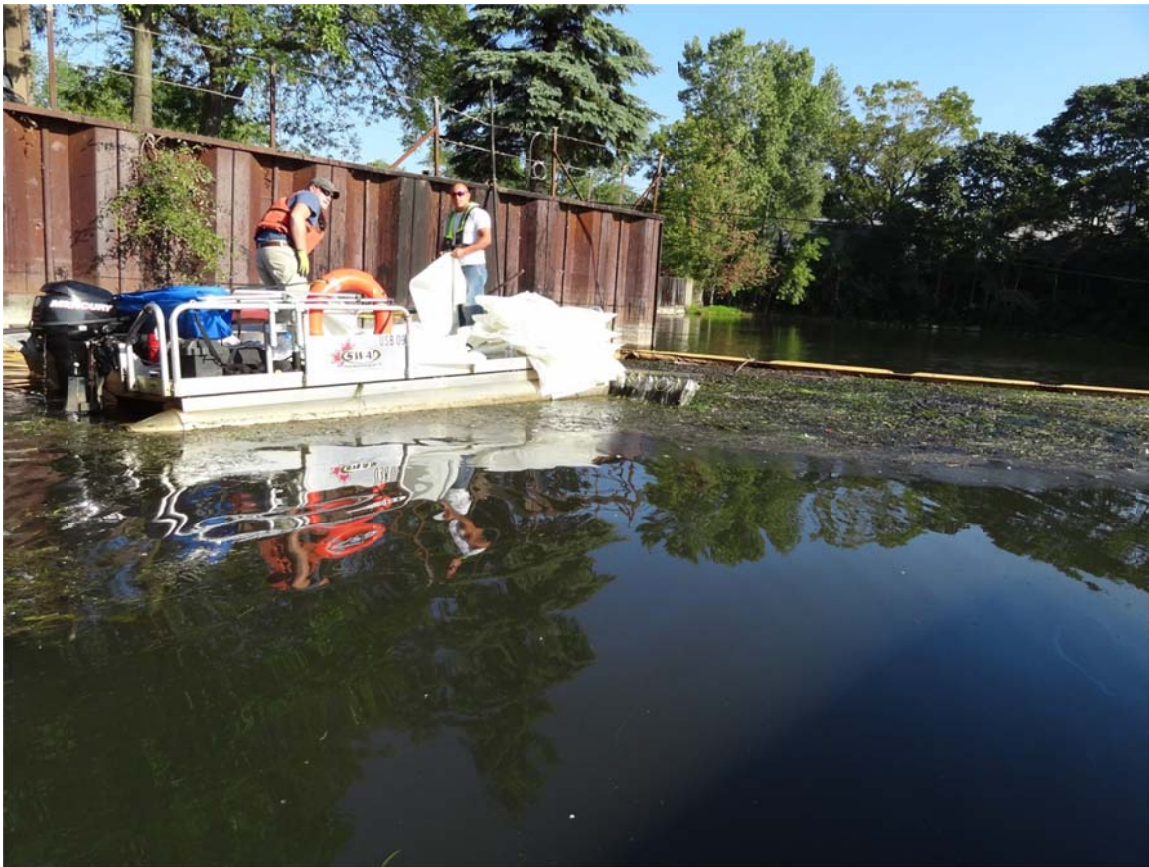
3. Crews removing debris from the control point at Ceresco Dam.

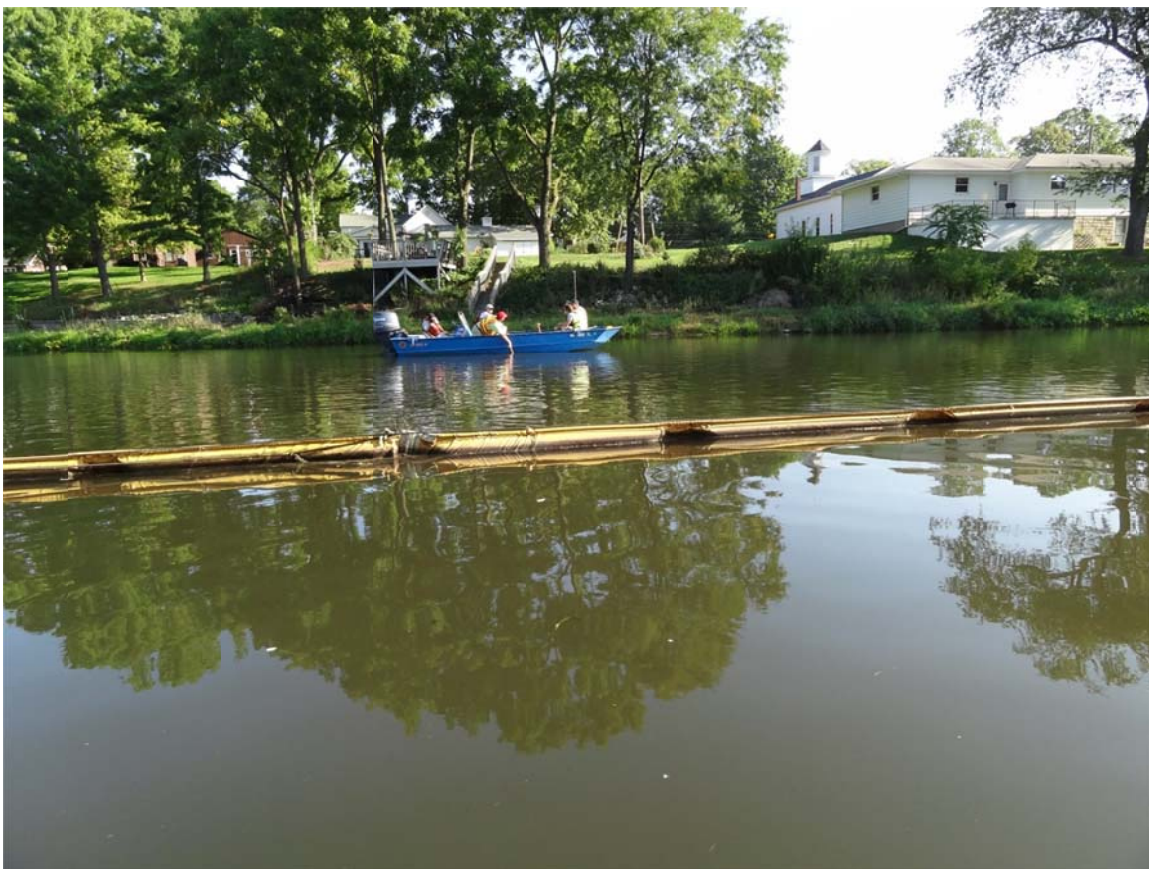
4. Sediment trap survey crew observed along RDB above Ceresco Dam.

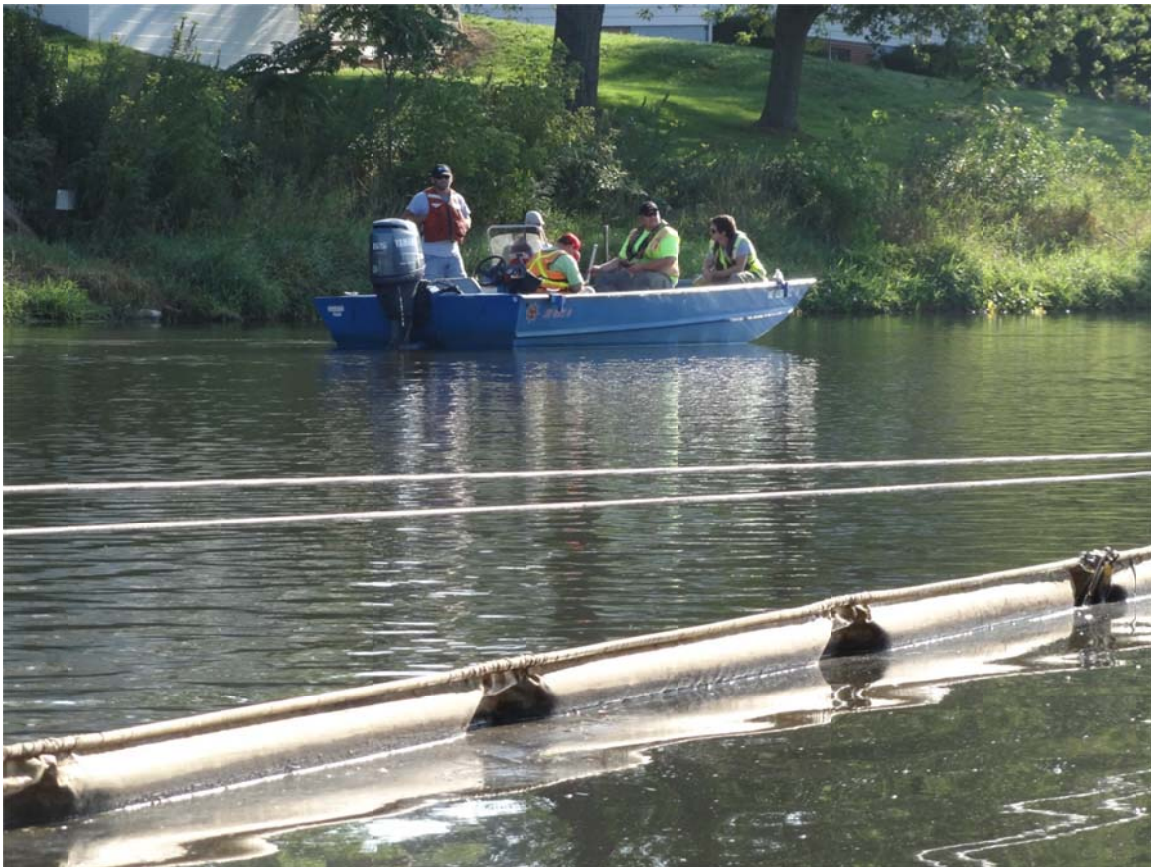
5. Sediment trap survey crew observed along RDB above Ceresco Dam.

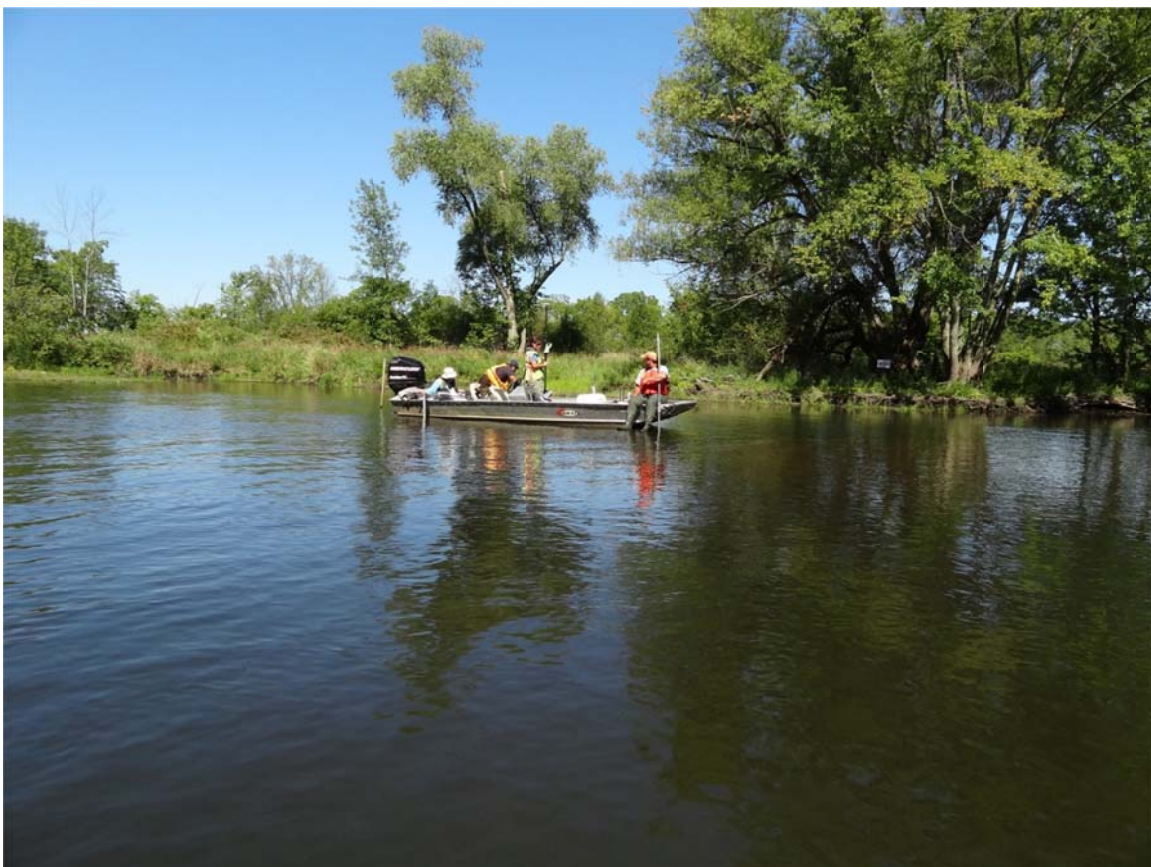
6. Sediment trap survey crew continued work near MP33.0 RDB.

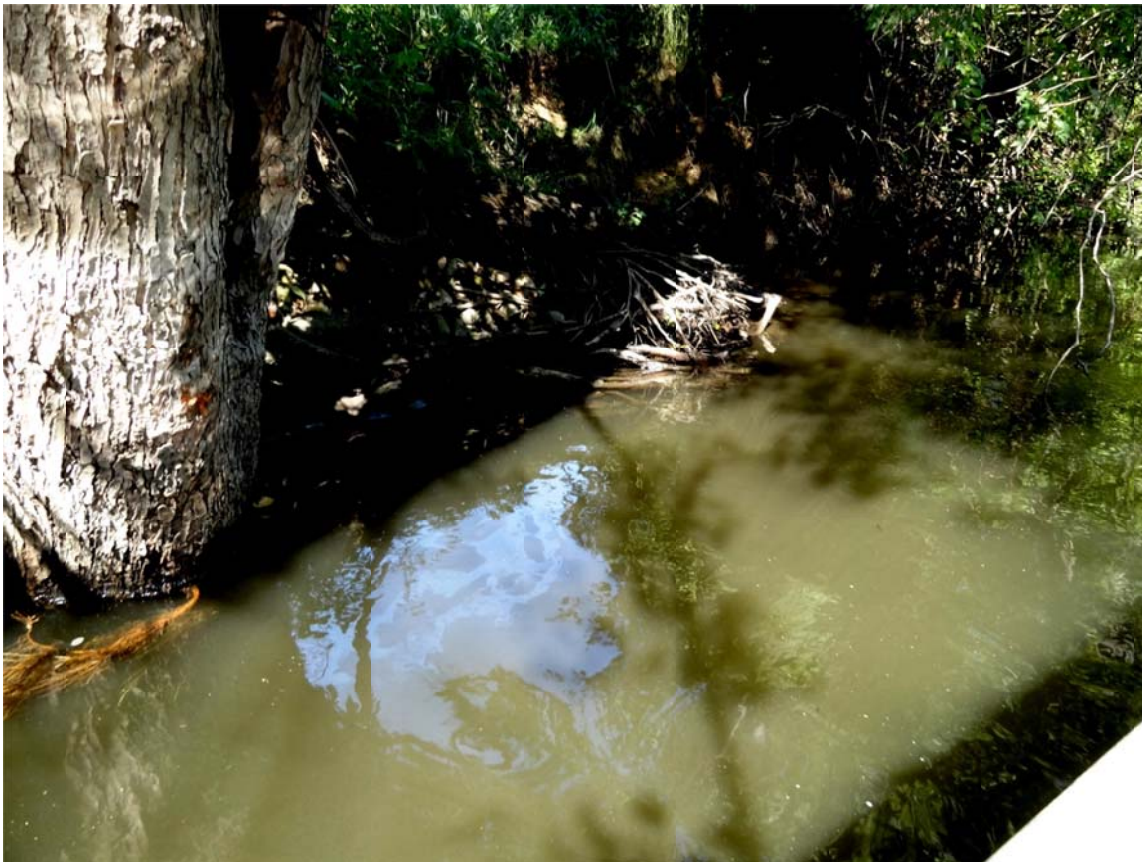
7. MP33.1 RDB, sheen and strong petroleum odor observed.

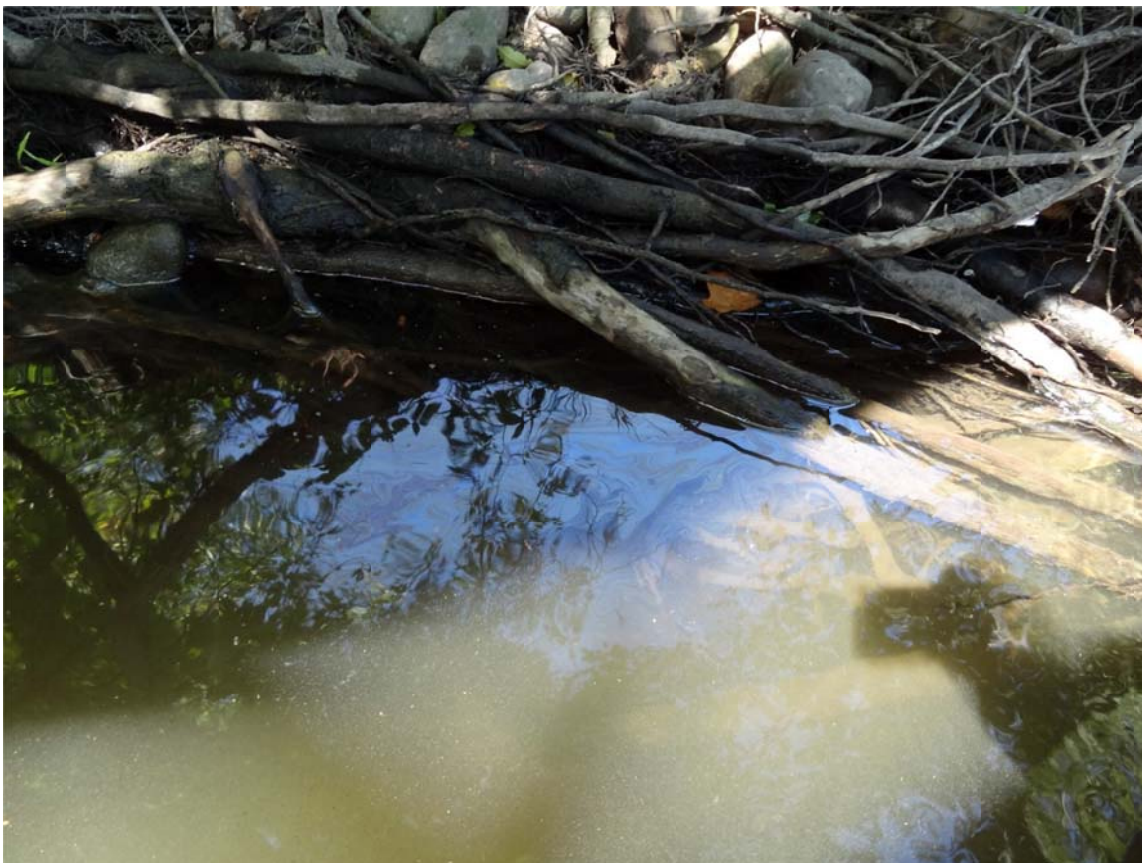
8. MP33.1 RDB, sheen and strong petroleum odor observed.

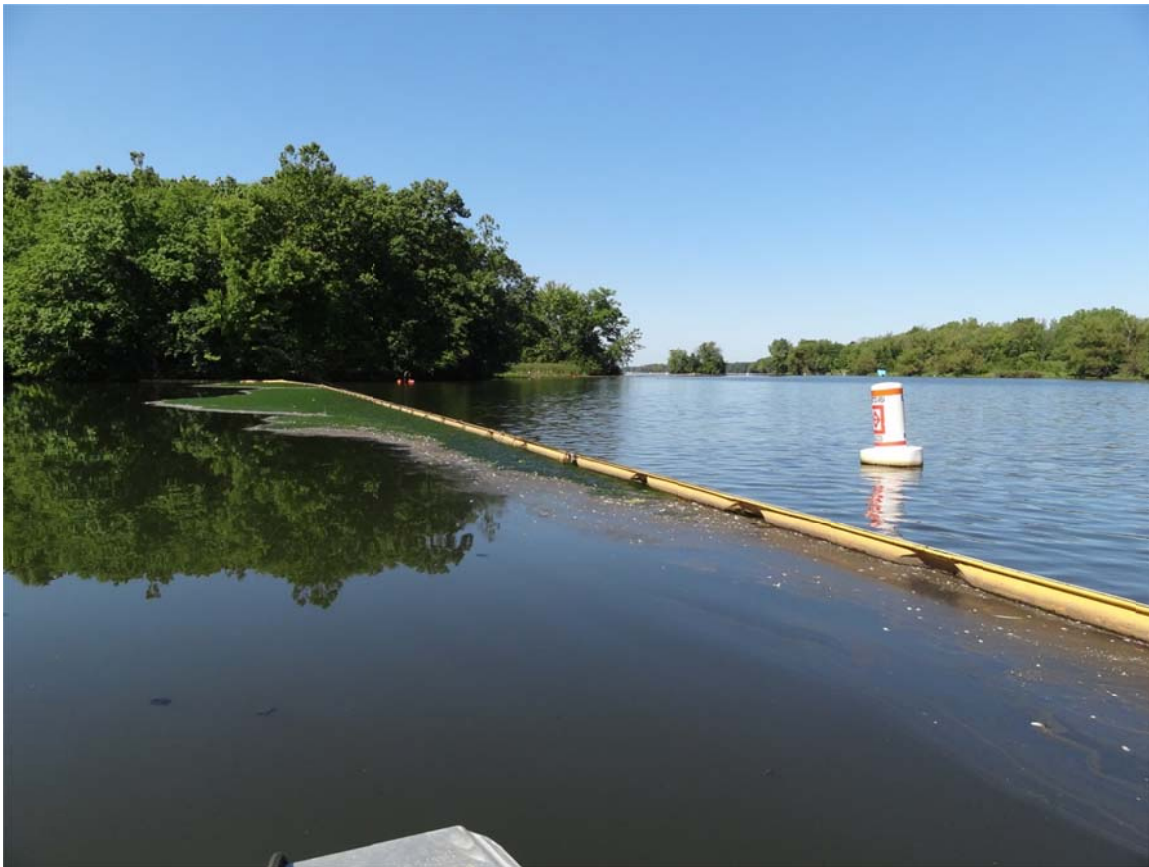
9. E4 system Containment Boom C2, sheen and debris observed within containment.

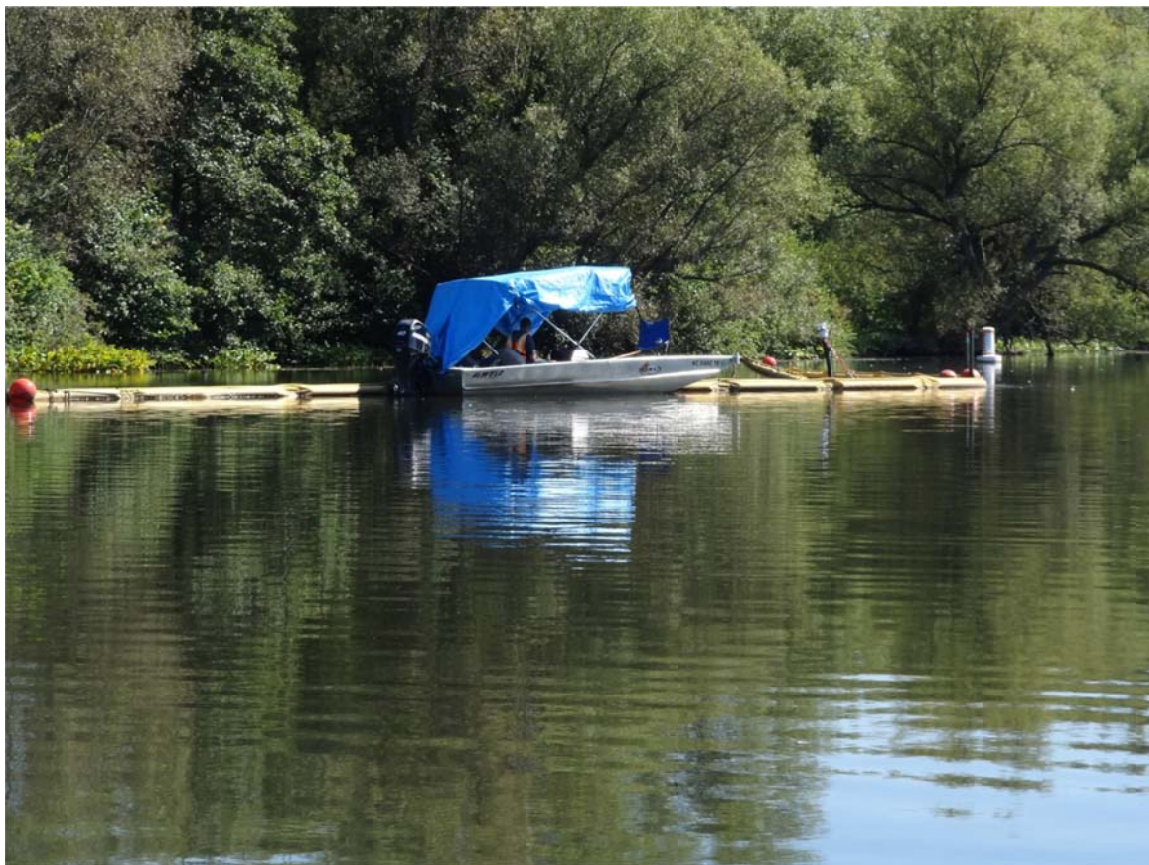
10. Crews inspecting boom and sediment curtain on north shore of Morrow Lake Delta.

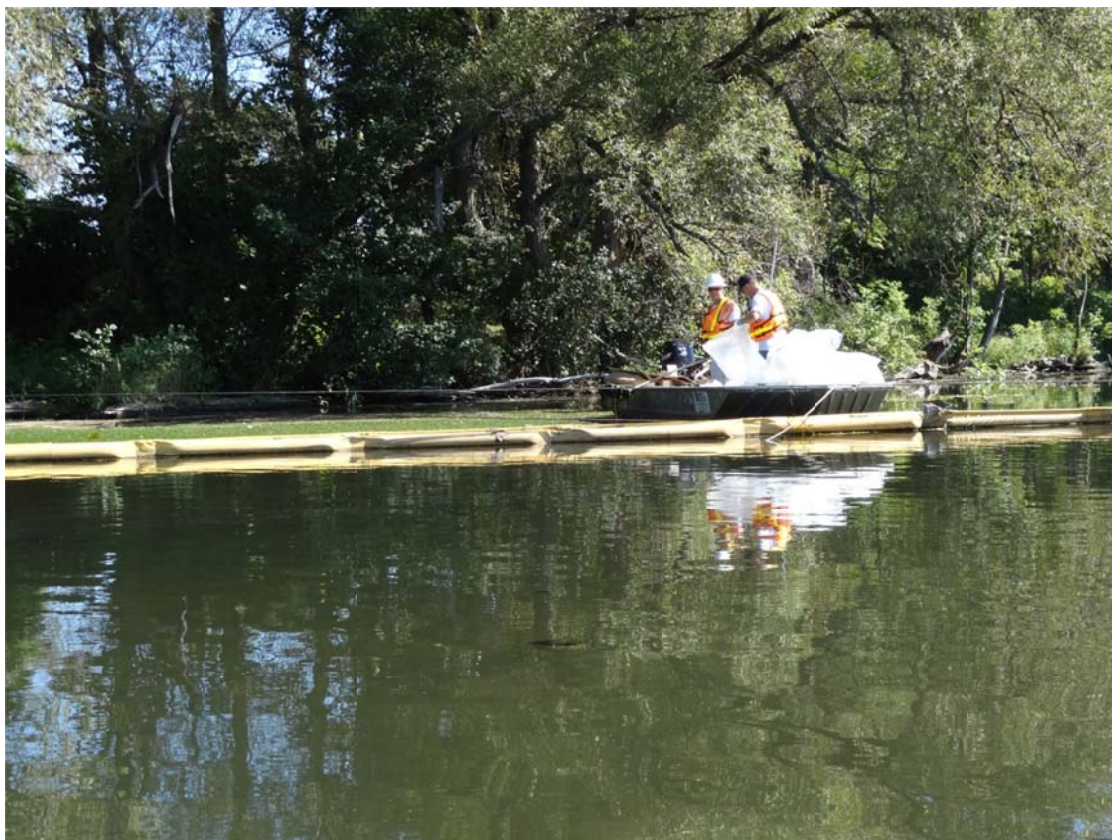
11. Crews removing vegetation and debris from E4.0 control point.

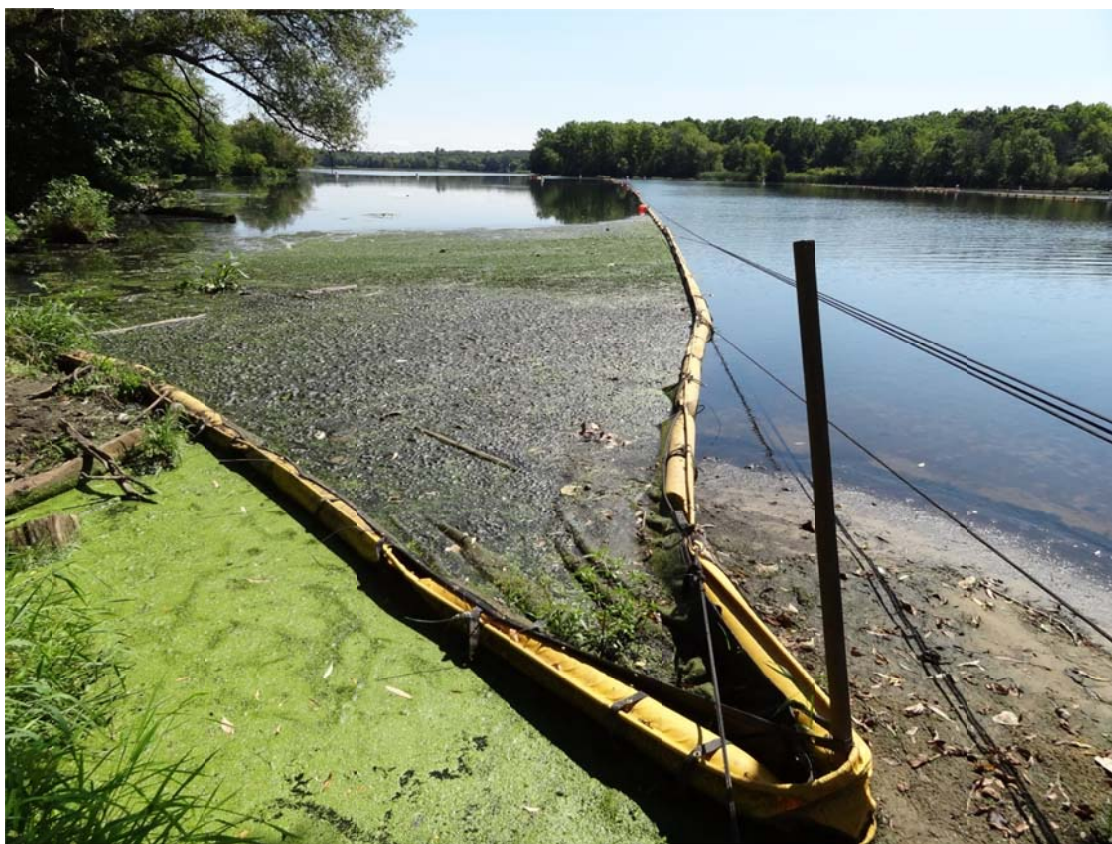
12. Debris and vegetation in E4.0 control point.

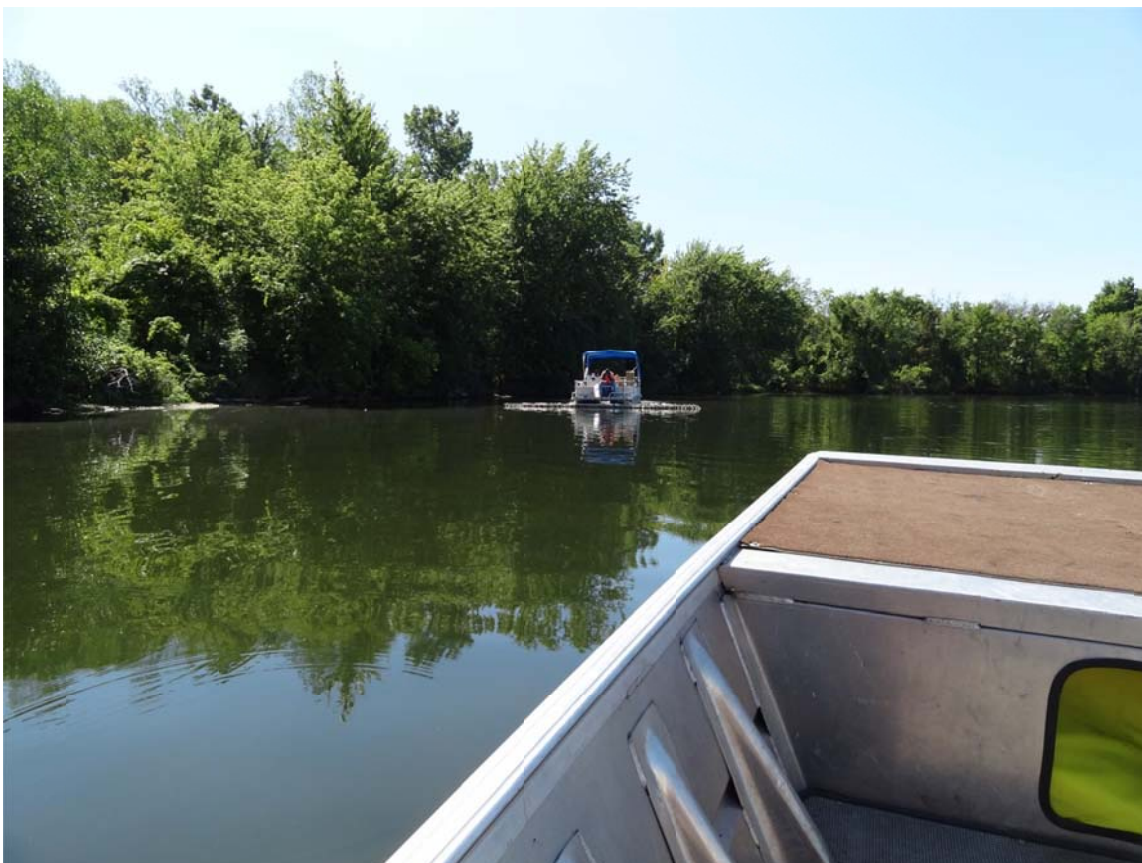
13. Sheen sweepers boat operating in south cove of Morrow Lake.

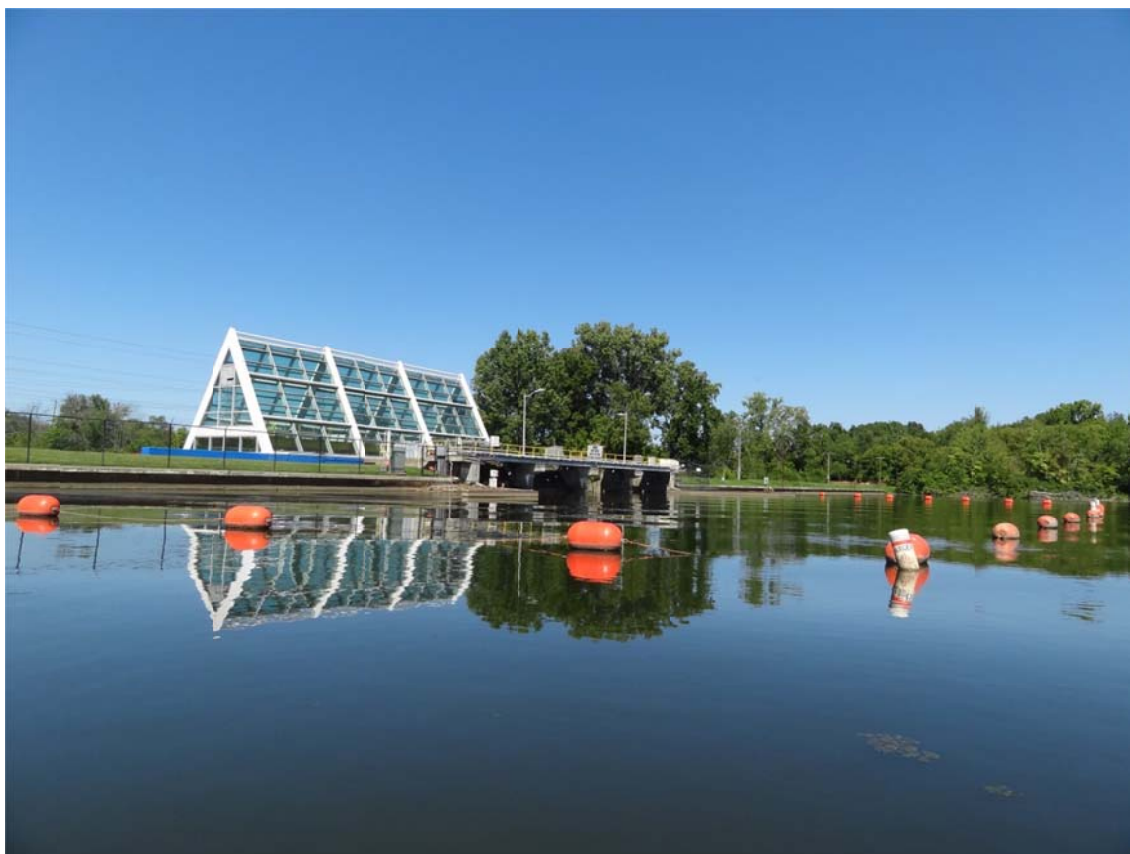
14. Morrow Lake Dam, no sheen observed.
